216-222 Old Brompton Road

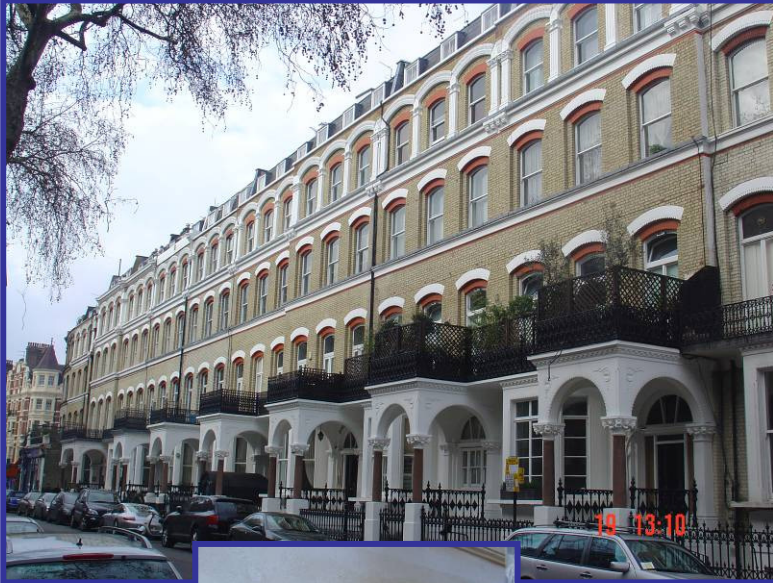
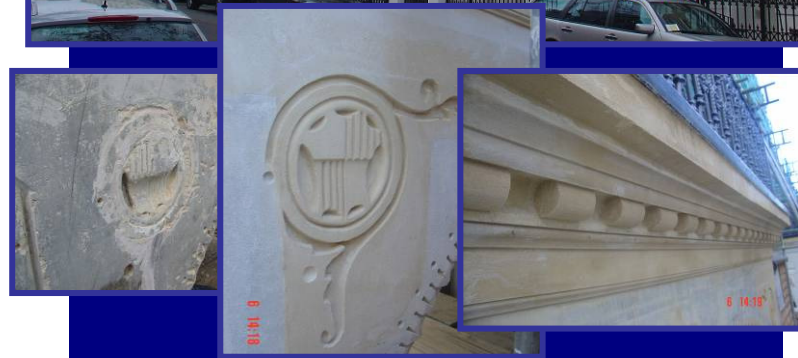
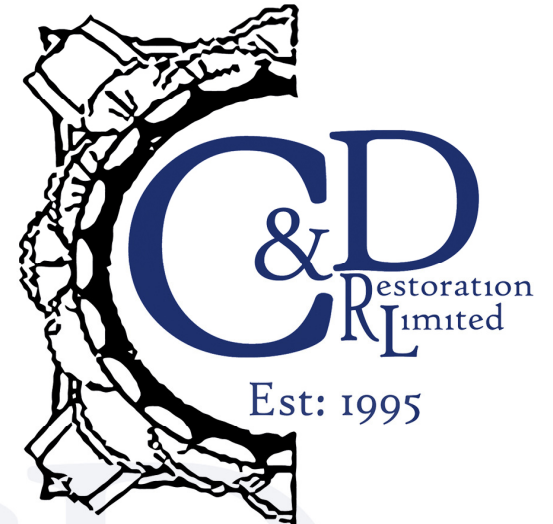
Extensive restoration works were carried out to the four painted, natural stone porticos. Paint was stripped from each portico using chemicals and the low pressure super heated DOFF system.

All moulds and profiles were cut back and restored by our team of craftsmen including all Corinthian capitals using bath stone mix.

Using skills honed over many years, C & D Restoration Limited undertook to repair and re-cast damaged floral capitals at the top of each of these columns.

Some of the stone mould designs on this building did not fit in with the architectural style of the surrounding properties. At the client's request, C & D Restoration Limited carried out a full inspection of the stonework and put their experience to work in developing a template which offered alternative portico design adjustments which could be incorporated to suit the aesthetic requirements. Our experienced craftsmen then worked to the template and re-worked the portico stonework accordingly.
